U. S. NAVY UNDERWATER SOUND LABORATORY FORT TRUMBULL, NEW LONDON, CONNECTICUT

> WATER FLOW PATTERNS ON A TOWED CYLINDER .

(4) USL-TM-USL Technical Memorandum No. 933-361-64

10 November 1964

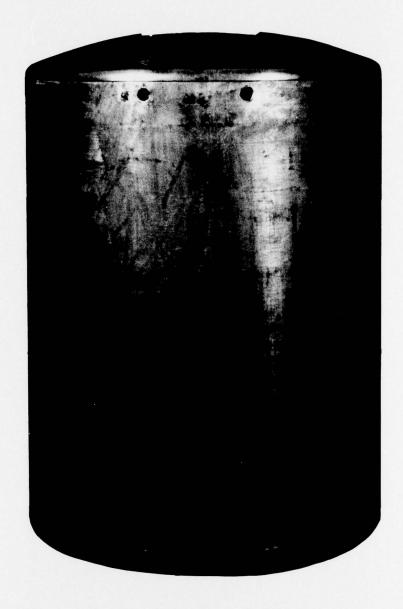
observed by inspecting the corrosion products (see figures 2 through 5).

- 1. The surface of the cylinder becomes covered with a more or less uniform distribution of pits. (Certain localized areas of the aluminum are cathodic to the main mass of aluminum).
- 2. Corrosion products form around the pits as shown on the diagram below for a similar process involving a sodium salt solution and iron.

- 3. The corrosion products in the form of sodium aluminate, tend to become streak formations (directly aft of the pits) due to water motion past the pits during the time the cylinder is towed.
- 4. The deposited sodium aluminate induces further corrosion along the flow lines.

Fig. 2 - Front View of Cylinder

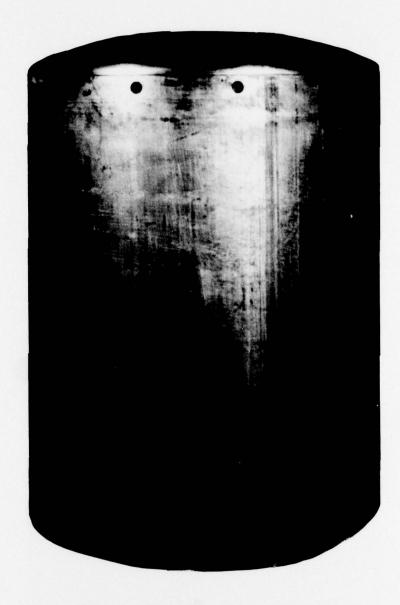
Fig. 3 - Port Side View of Cylinder

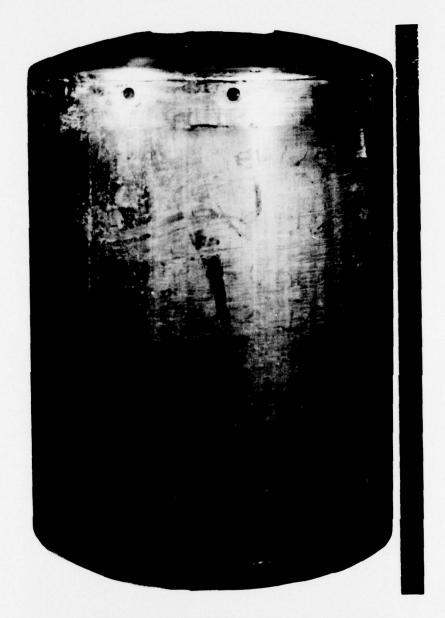
Fig. 4 - Starboard Side View of Cylinder

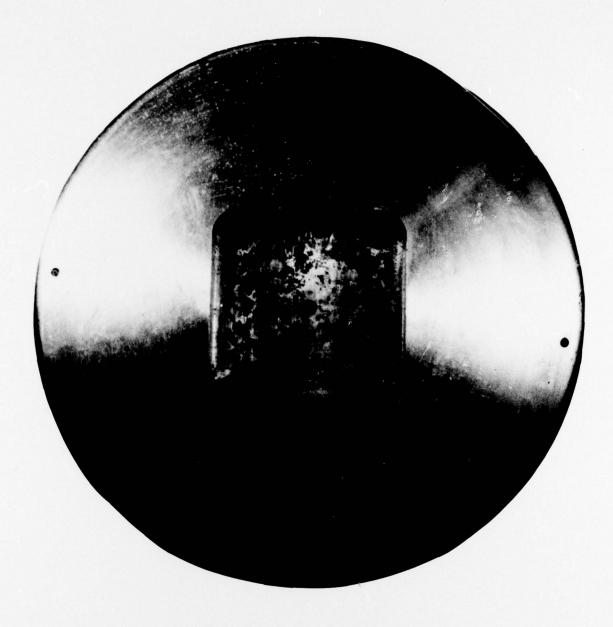
Fig. 5 - Top View of Cylinder

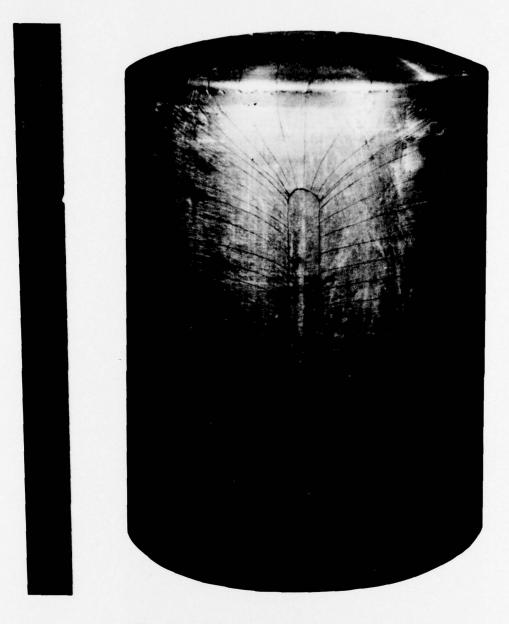
In order to make the patterns more discernible, streamlines were plotted on the body by constructinp tangents to the streaks by means of a french curve (see figures 6 through 9). Areas in which there is no flow are cross-hatched. The angular position of the lines of separation on the cylinder are shown in Figure 10.

Fig. 6 - Front View of Cylinder

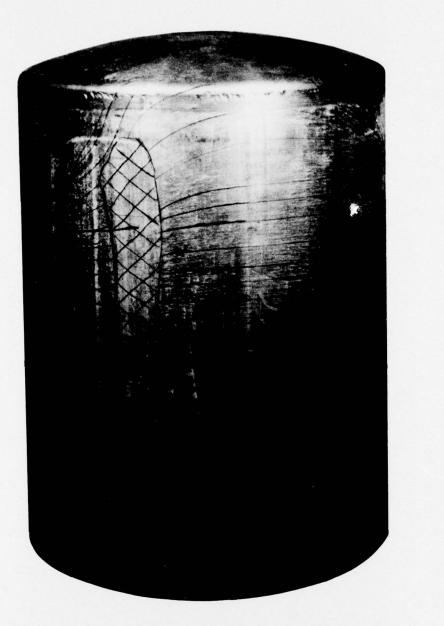
Fig. 7 - Port Side View of Cylinder

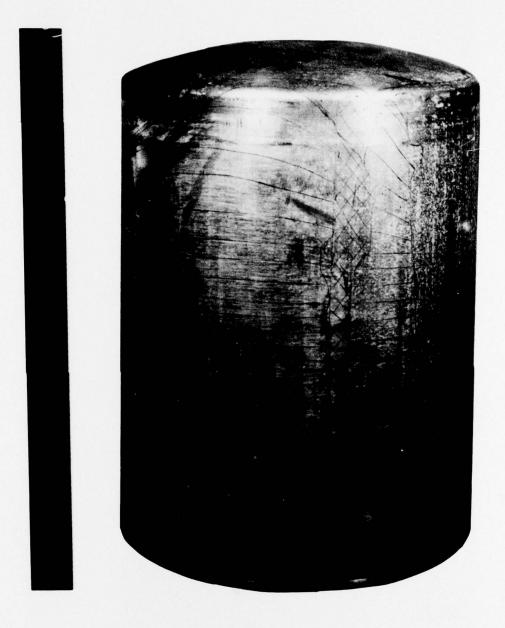
Fig. 8 - Starboard Side View of Cylinder

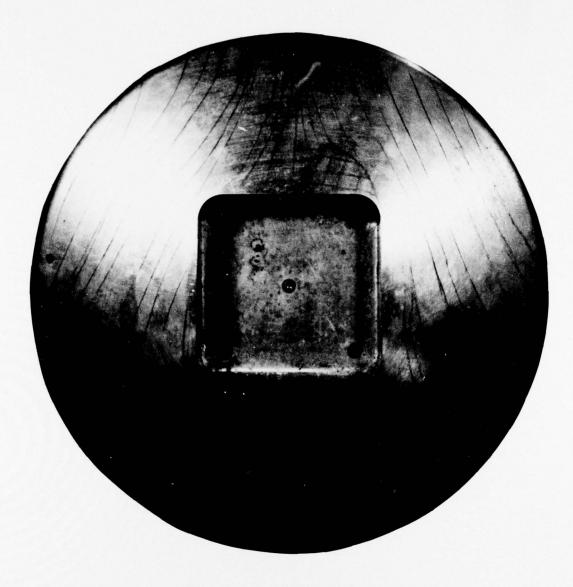
Fig. 9 - Top View of Cylinder

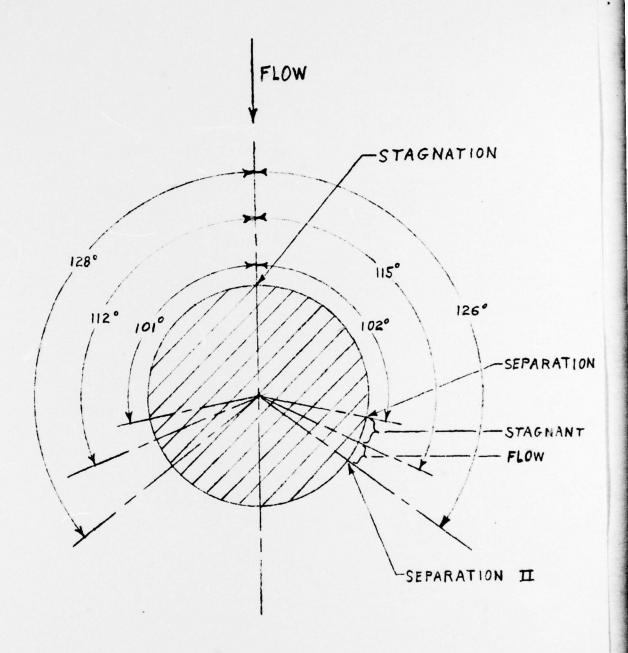
FIG. Nº 10 TO USL TECH MEMO 933-361-64

The flow appears to separate and then return to the surface to separate a second time. The initial separation occurs at 1020. The

theoretical solution using the Blasius series indicates separation at 108.80. (See reference (b)).
